INSTALLATION RESTORATION PROGRAM

REMEDIAL INVESTIGATION REPORT

MINNESOTA AIR NATIONAL GUARD BASE
DULUTH INTERNATIONAL AIRPORT
DULUTH, MINNESOTA
VOLUME 1

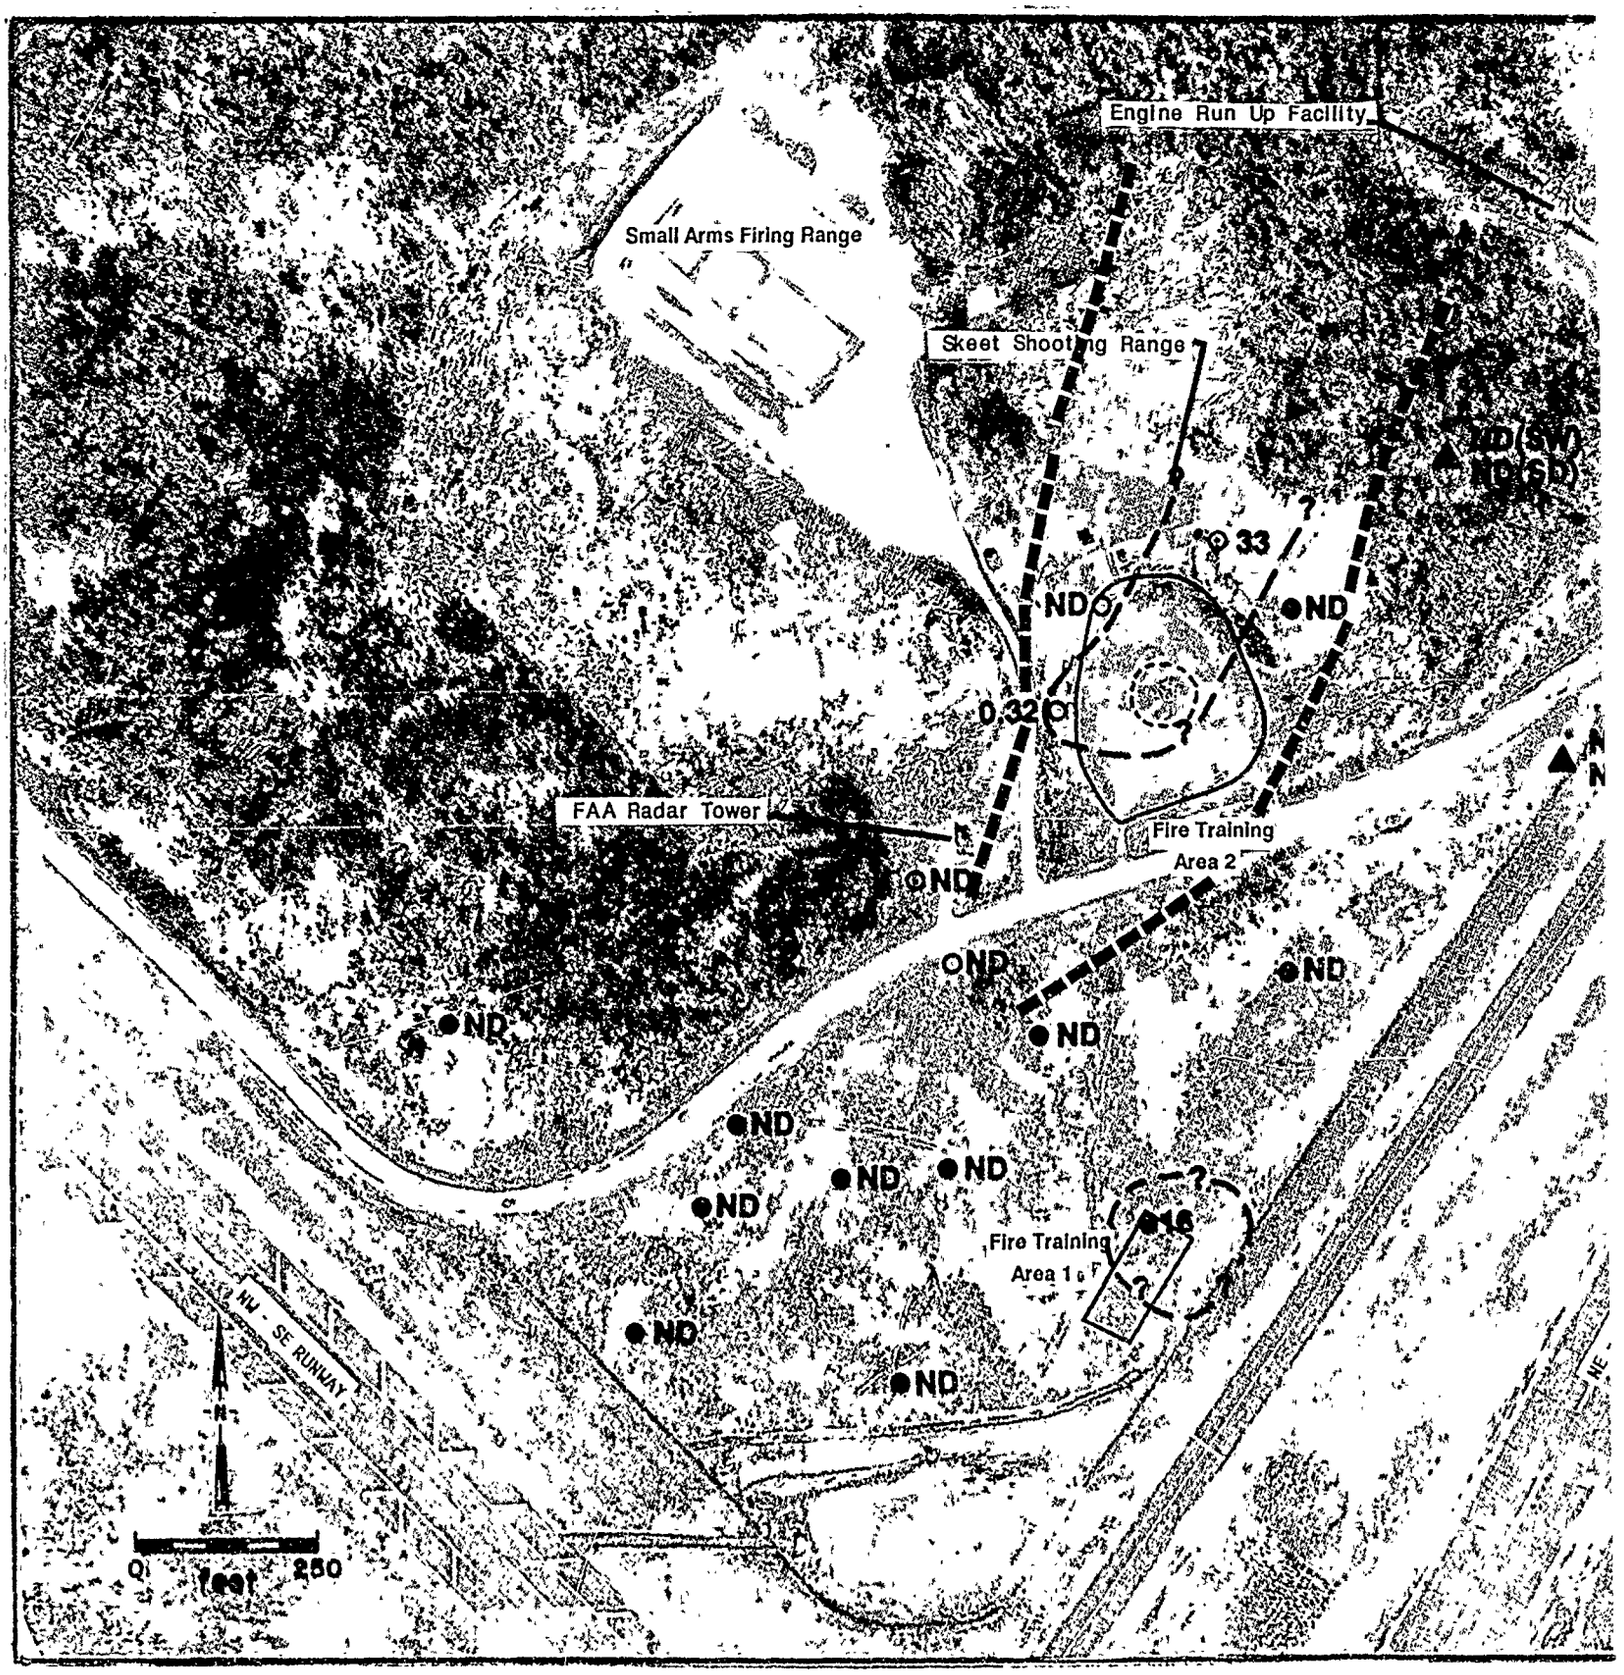
Ground water and soil at Site 2, which includes Fire Training Areas 1 and 2 are contaminated with significant levels of volatile organic compounds. The compounds trichloroethene, trans-1,2-dichloroethene, and vinyl chloride were found in ground water downgradient from Fire Training Area 2 at levels above MCLs. Ground water at the site where Fire Training Area 1 is believed to have been located contained trichloroethene at a concentration in excess of the MCL.

Figure 4-1 Estimated Areal Extent of Trichloroethene Contamination in Ground Water at Site 2.

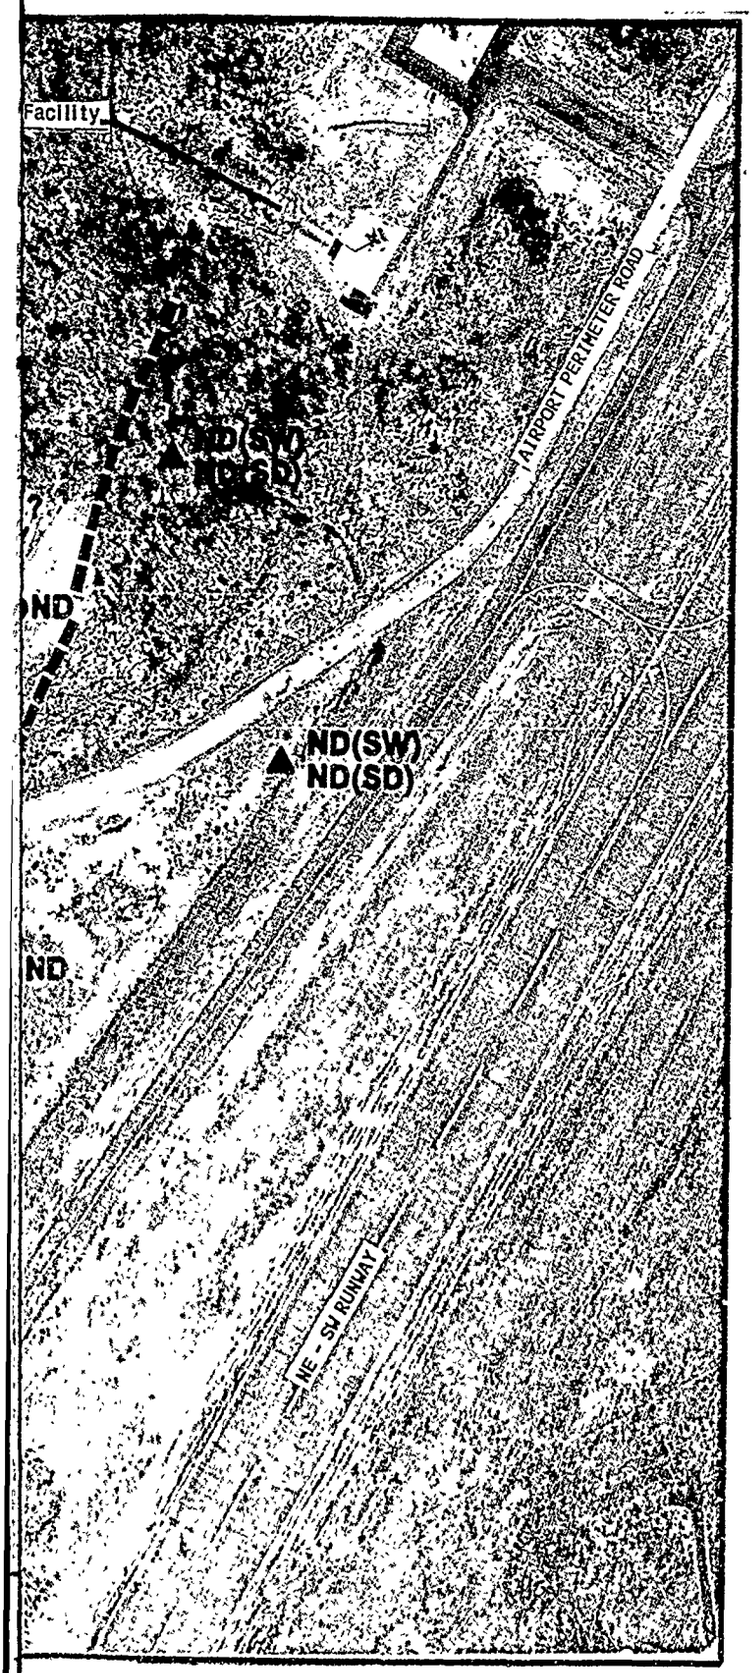
The distribution of trichloroethene and trans-1,2-dichloroethene in the ground water indicates a contaminant plume extending from FTA-2 to the northeast, hydraulically downgradient, toward an unnamed stream as shown on Figures 4-1 and 4-2. The concentration of trans-1,2-dichloroethene decreases downgradient from FTA-2, but in contrast, trichloroethene increases in concentration at the farthest downgradient well.

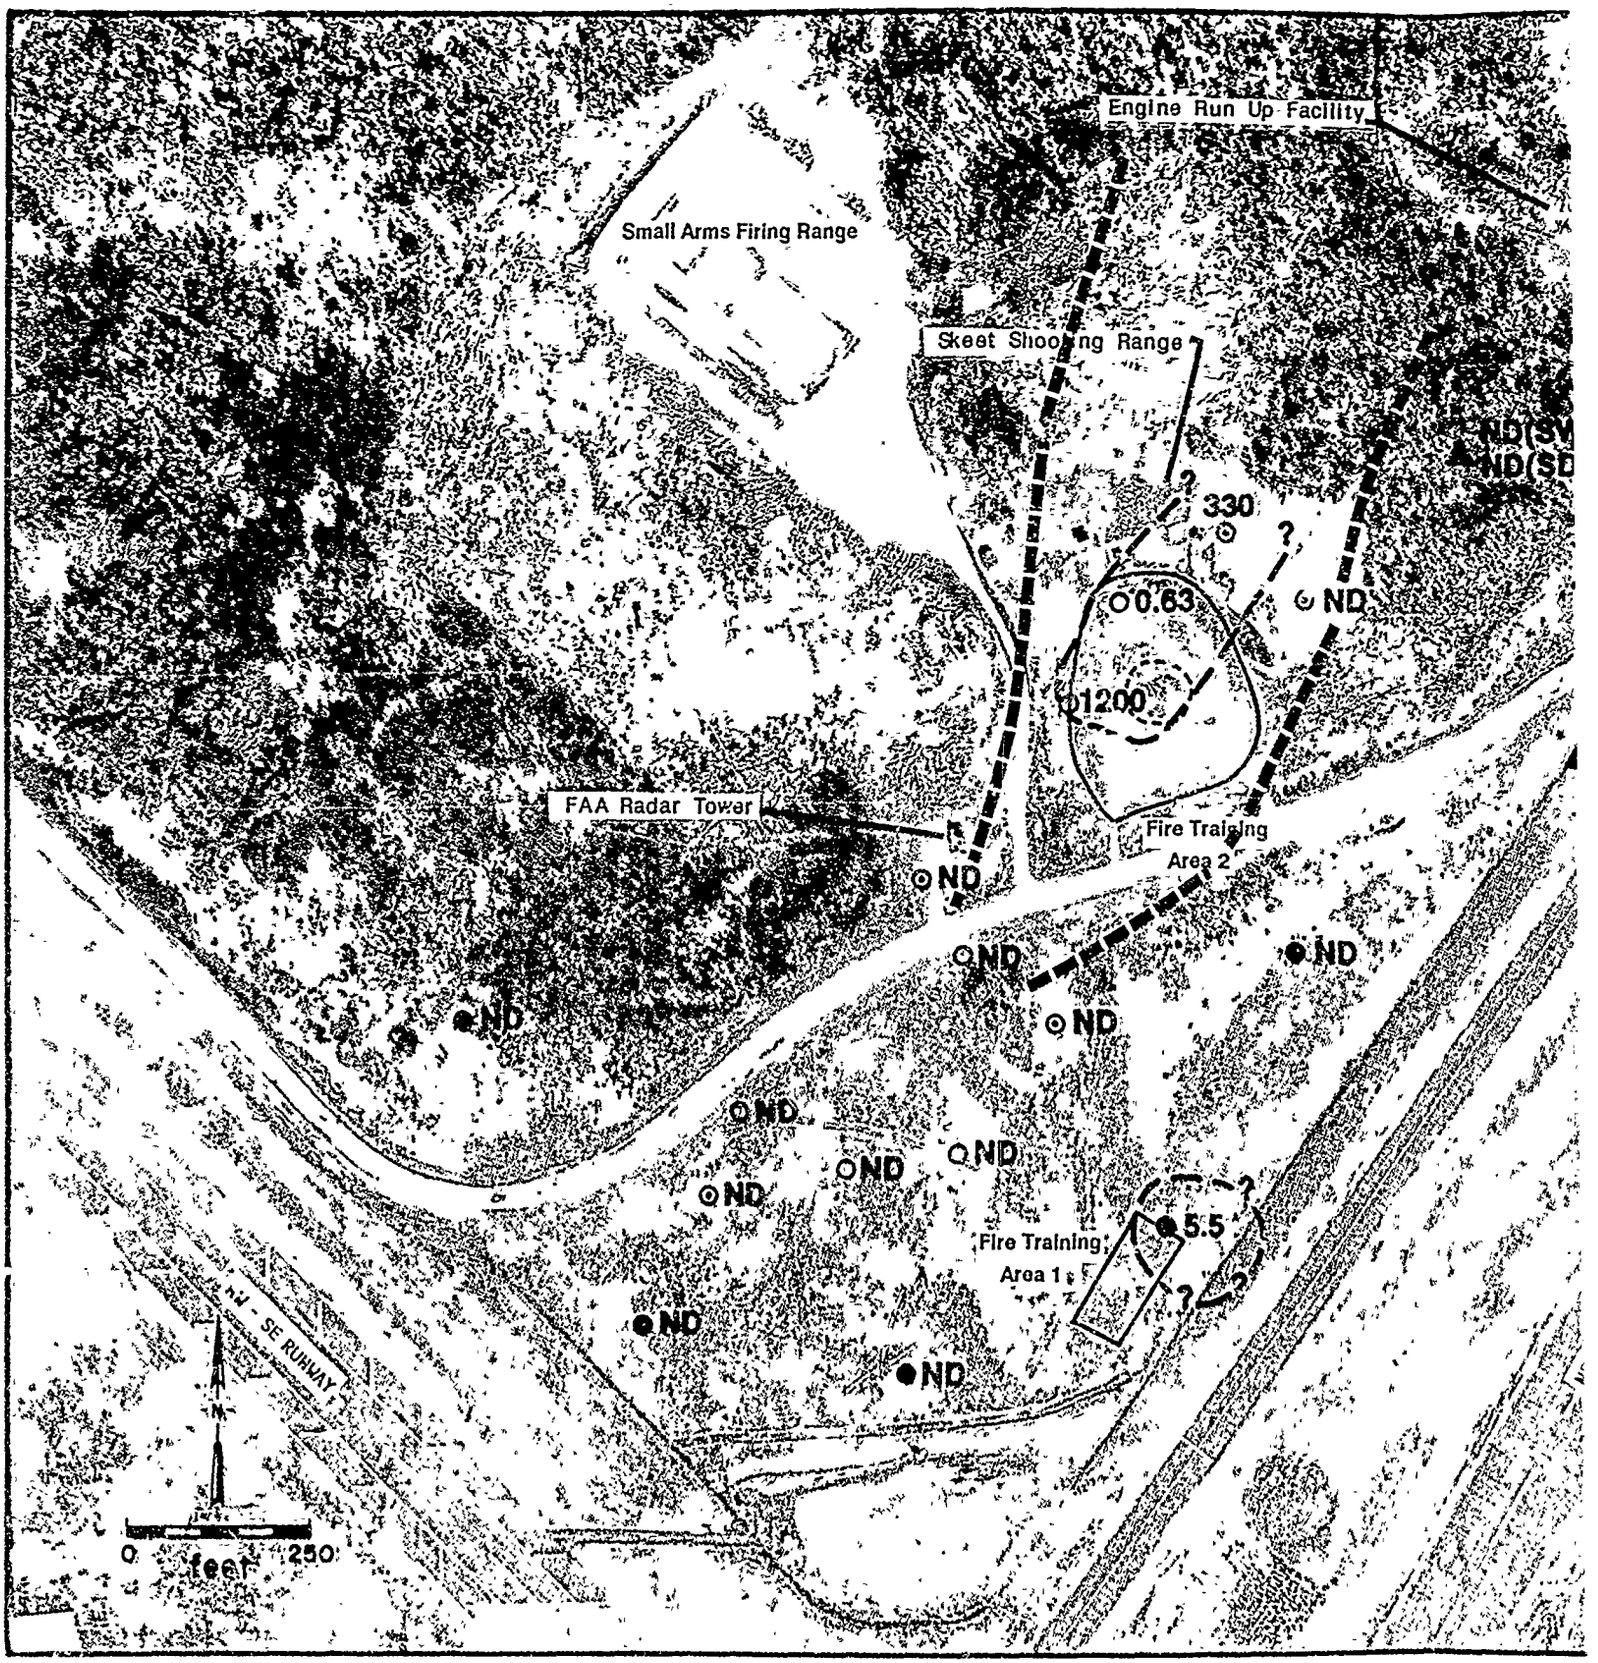
Figure 4-2 Estimated Areal Extent of Trans-1,2-Dichloroethene Contamination in Ground Water at Site 2.

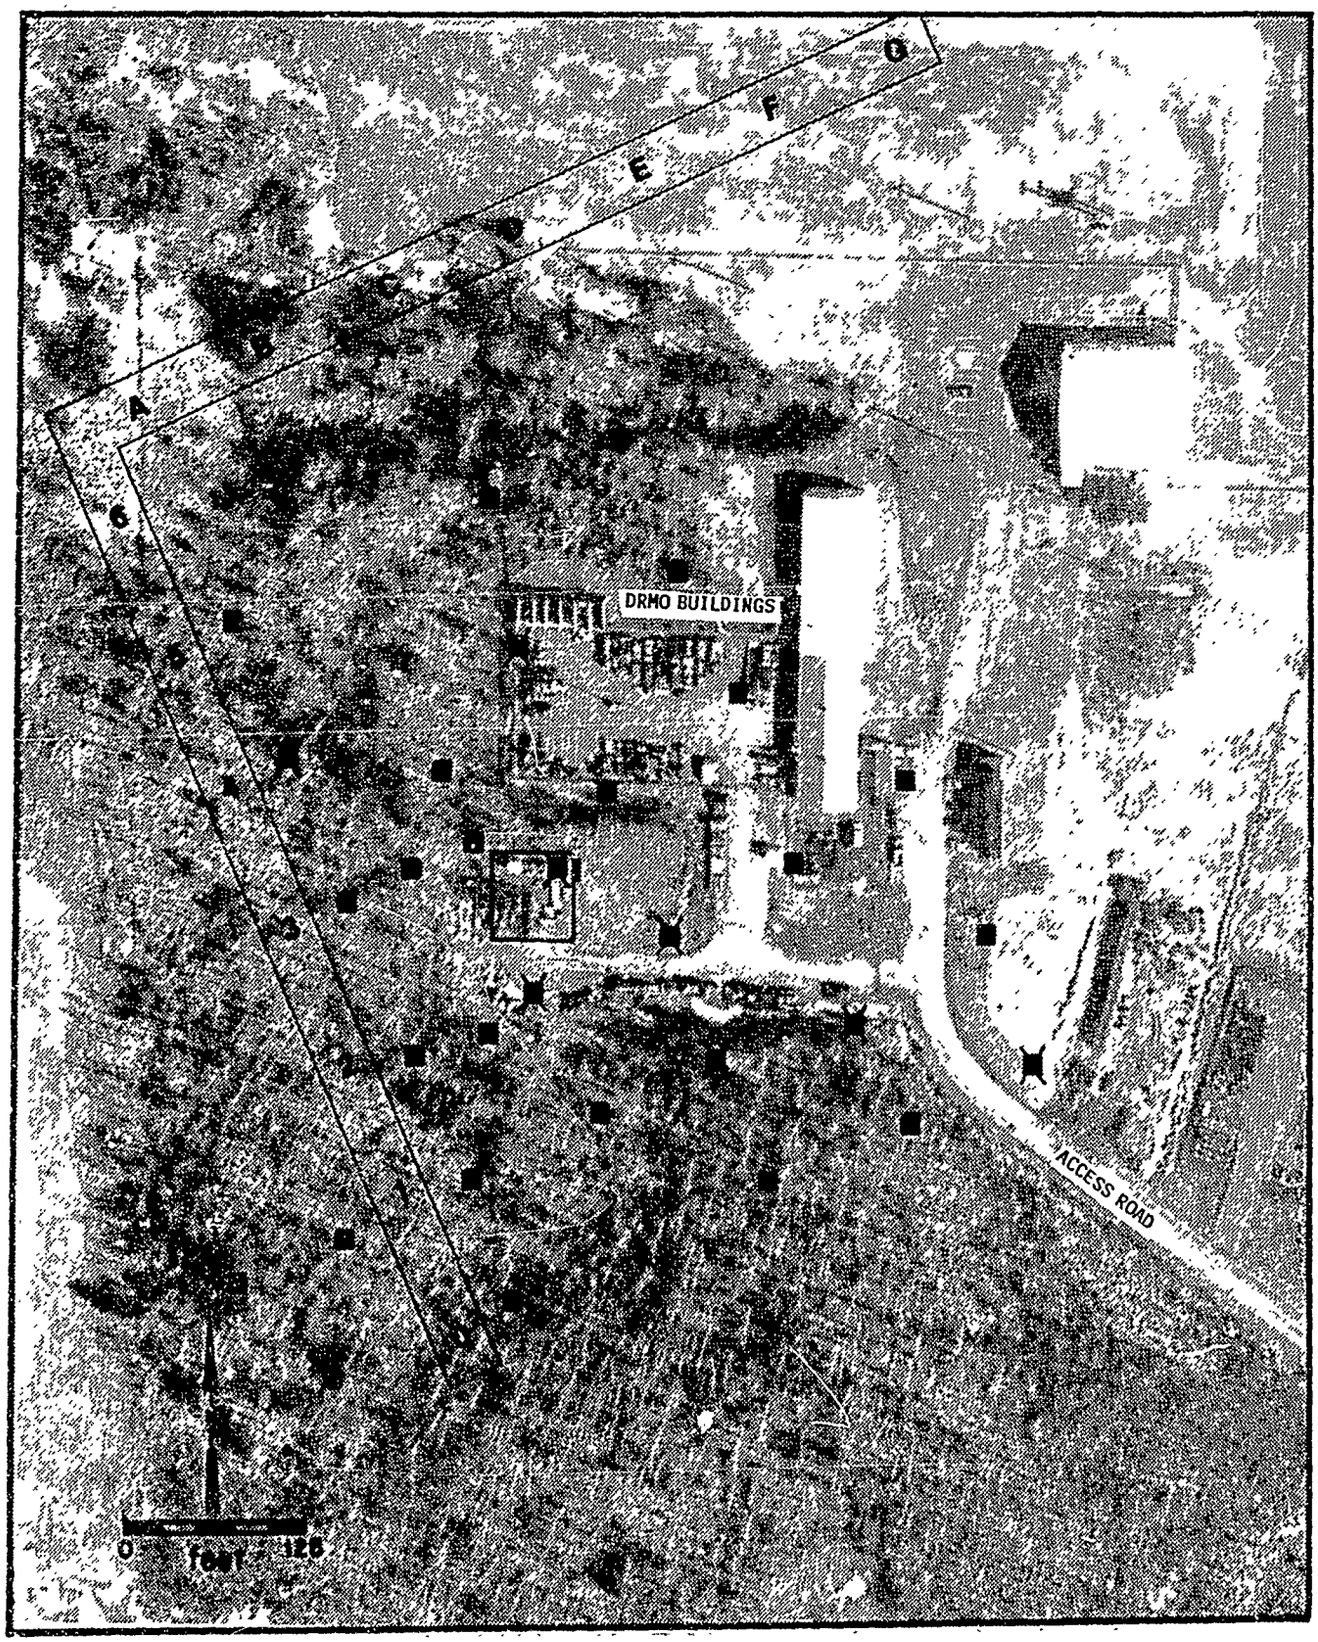
Figure 4-3 Distribution of Near Surface Soil Pesticide and PCB Occurrences at Site 3.

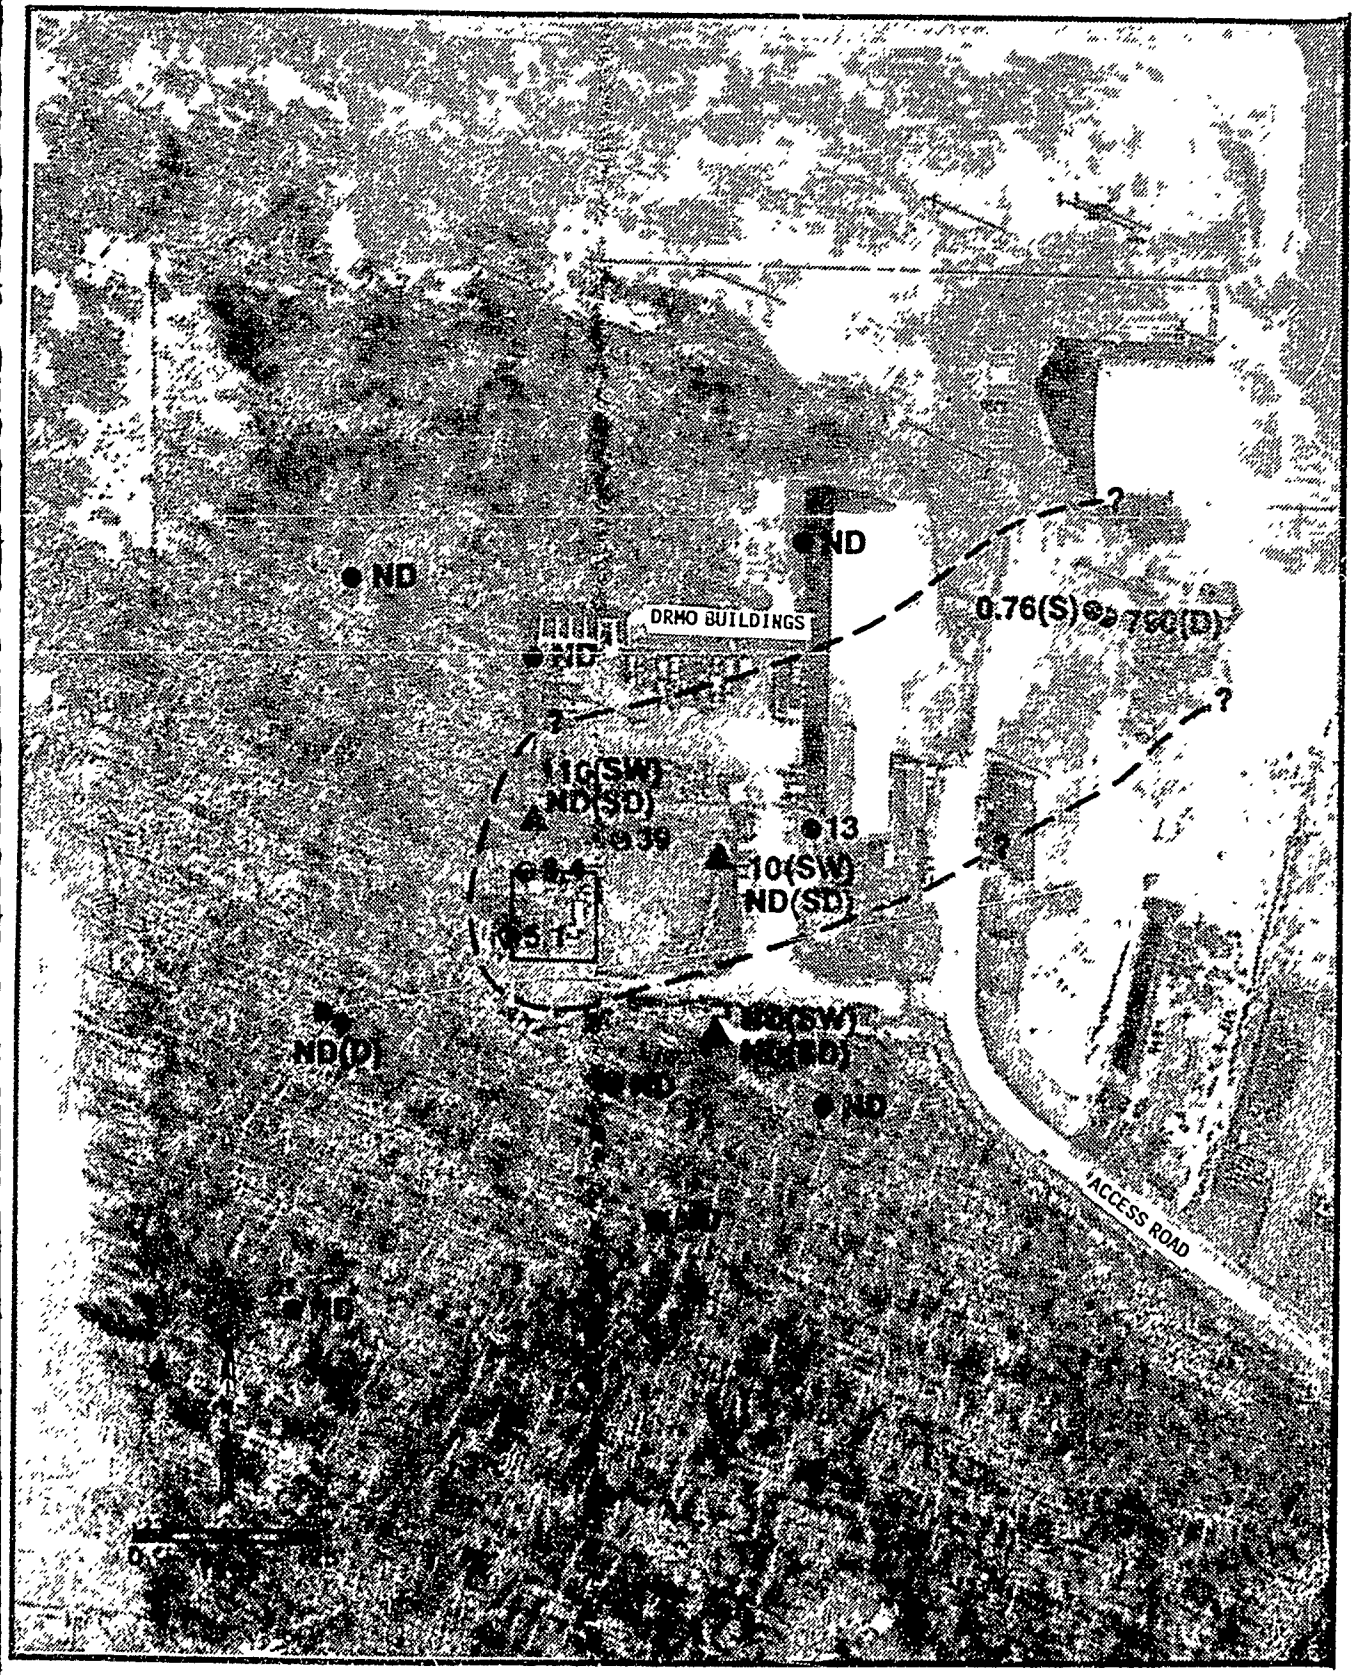
Ground water and surface water at Site 3, a formerly used storage pad behind the Defense Reutilization and Marketing Office (DRMO) (DPDO Storage Area "C"), are contaminated with significant levels of volatile organic compounds. Several halogenated volatile organic compounds were detected in the ground water at levels above MCLs for the respective compounds. The compound 1,1,1-trichlorethane was found most often in the ground water and at the highest concentrations followed by trichloroethene and tetrachloroethene. Trichloroethene was also detected in two water samples from the drainage ditch that adjoins Site 3 at levels above the MCL for that

Figure 4-4 Estimated Areal Extent of Trichloroethene Contamination in Ground Water at Site 3.

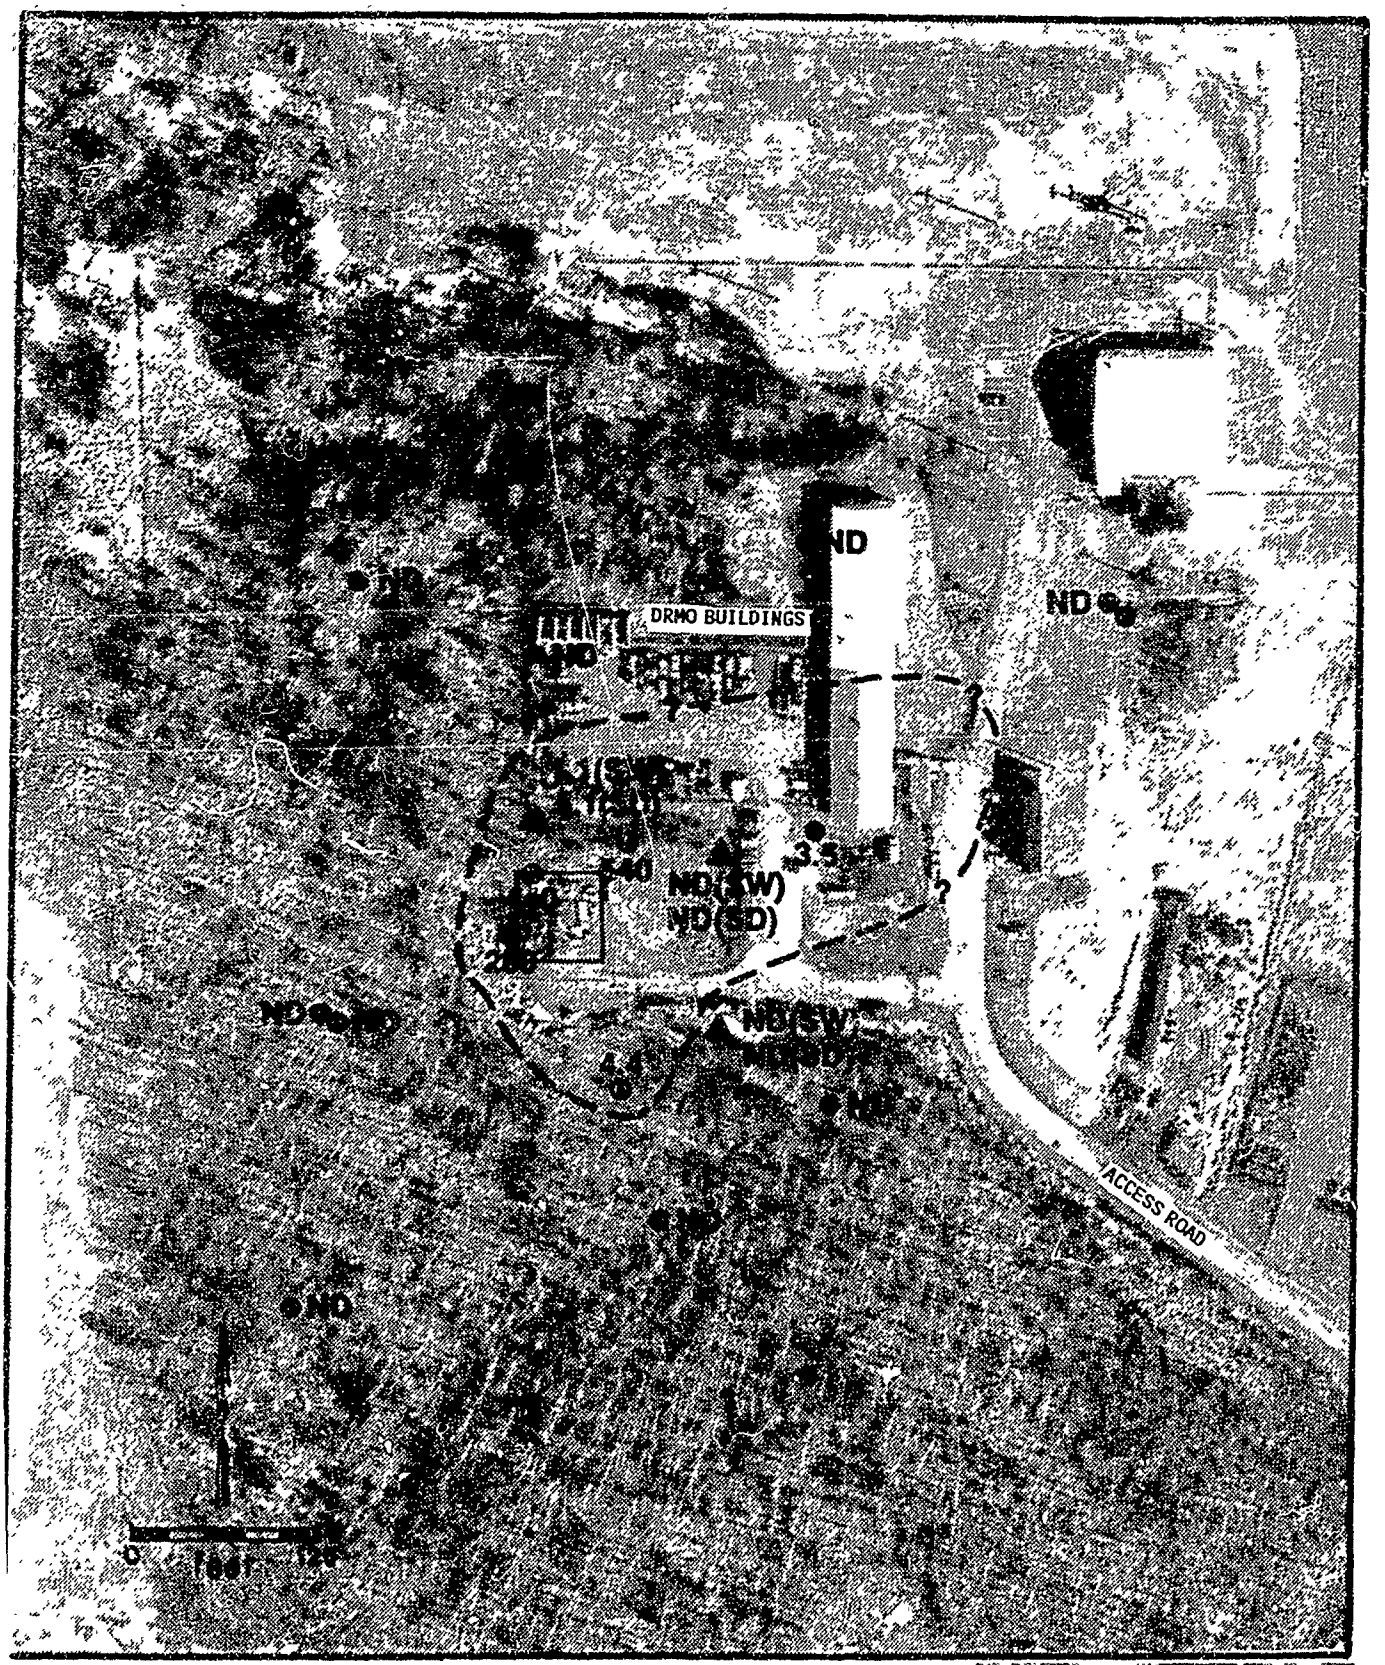
Figure 4-5 Estimated Areal Extent of Tetrachloroethene Contamination in Ground Water at Site 3.

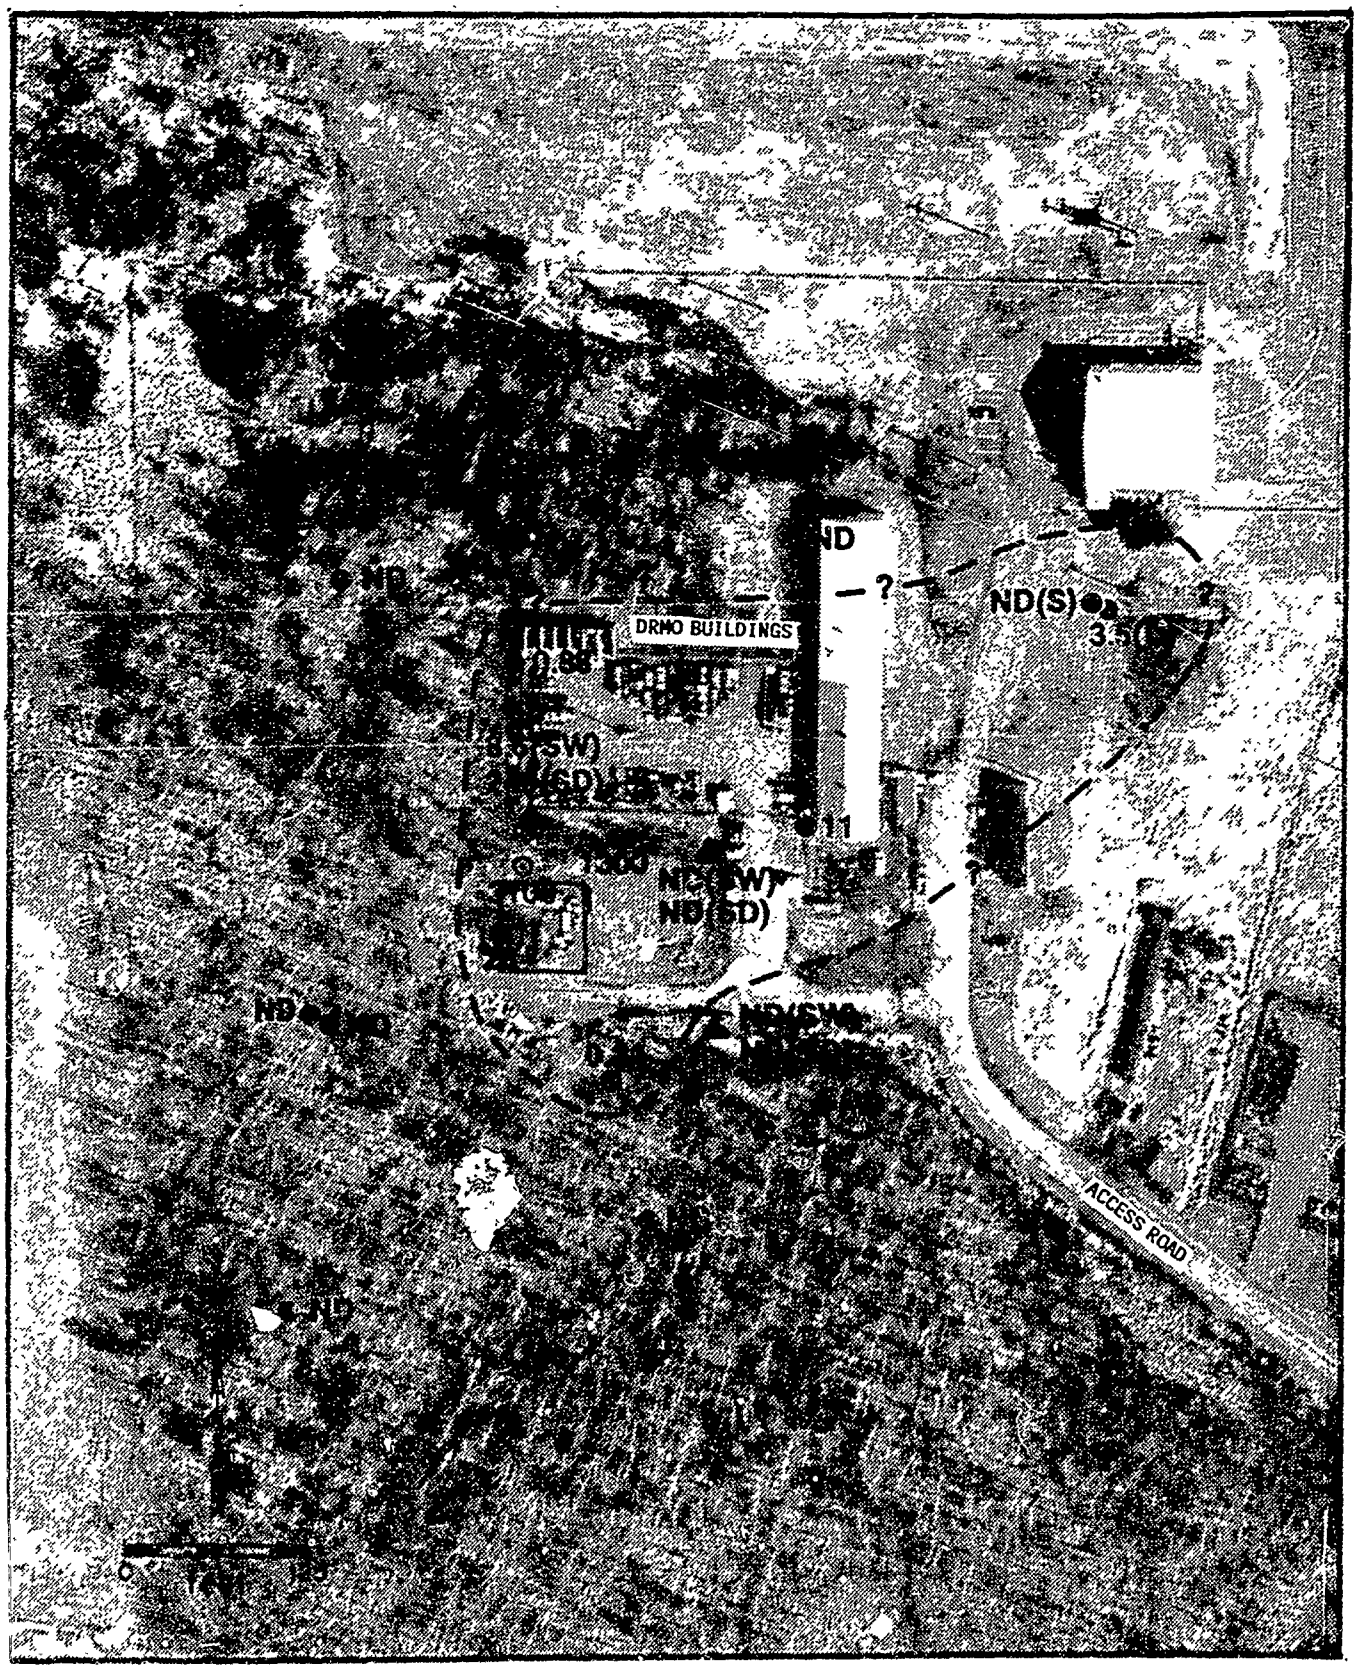
Figure 4-6 Estimated Areal Extent of 1,1,1 Trichloroethane Contamination in Ground Water at Site 3.

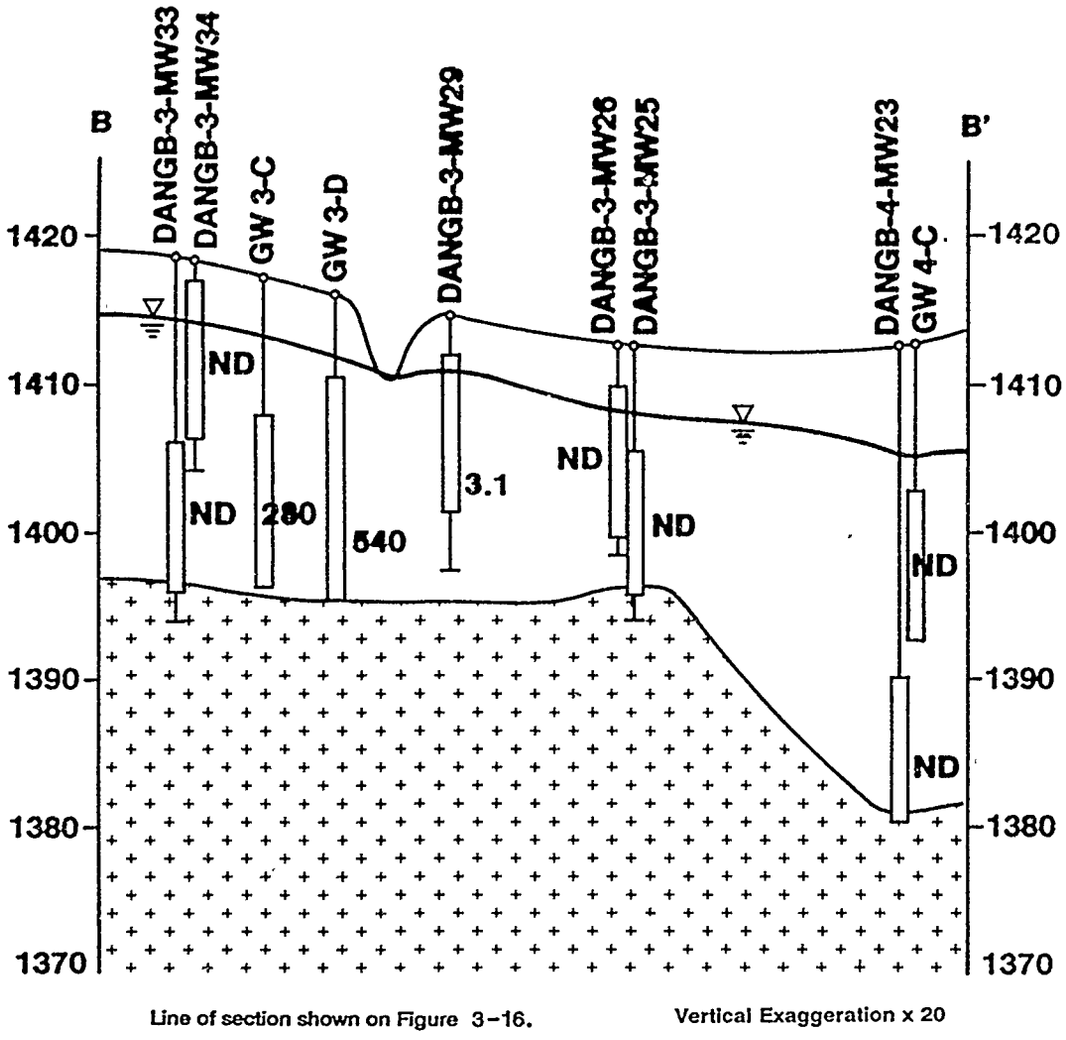
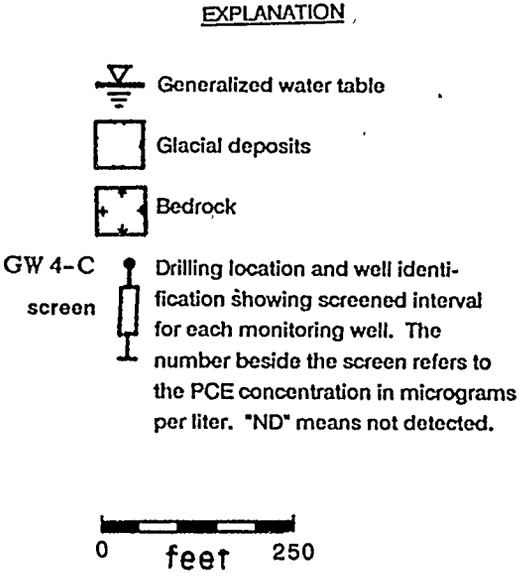
Figure 4-7 Vertical Distribution of Trichloroethene Contamination in Ground Water at Site 3.

Chemical data from wells screened at different depths suggest that vertical as well as horizontal contaminant gradients exist. The vertical distributions of 1,1,1-trichloroethane, tetrachloroethene, and trichloroethene show that concentrations of these contaminants increase with depth in the glacial till and that contaminants are concentrated near the bedrock contact (Figures 4-7 to 4-9). The vertical distributino of trans-1,2-dichloroethene is similar to that of trichloroethane and that of 1,1-dichloroethane is similar to that of 1,1,1-trichloroethene.

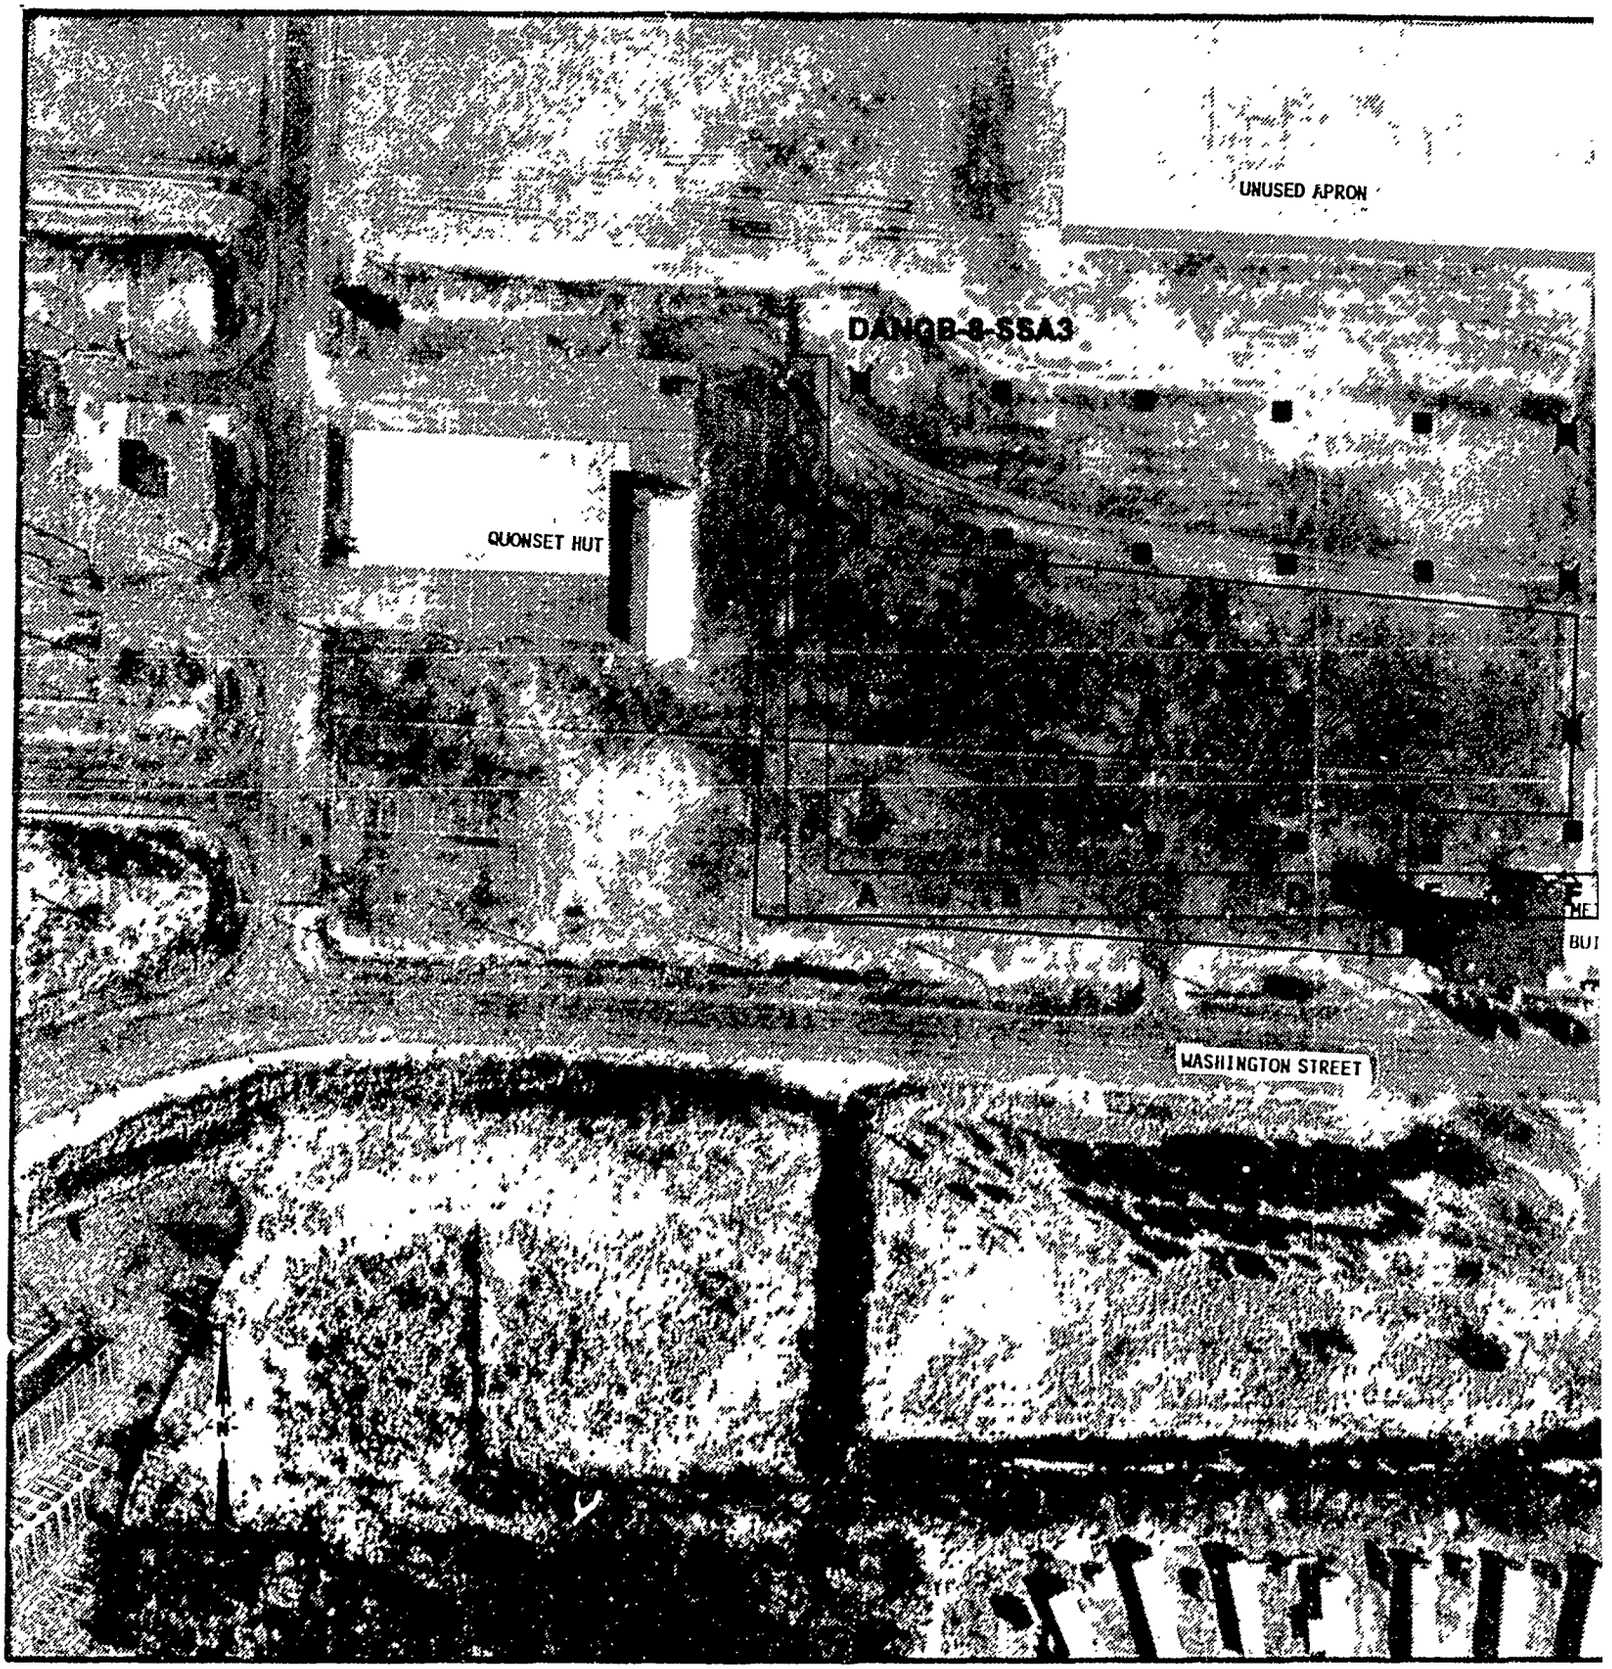
Contamination in general at Site 8, the former DPDO Storage Area, is not significant. Petroleum hydrocarbons were found in significant concentrations in one sediment sample and two soil samples. A significant level of pesticides was found in one soil sample and PCBs at a trace level were found in another soil sample. The data base for these results included 15 soil samples from 5 boreholes, 24 surface soil samples, and 3 sediment samples.

Figure 4-10 Location of Pesticide and PCB Occurrences in Surface Soils at Site 8.

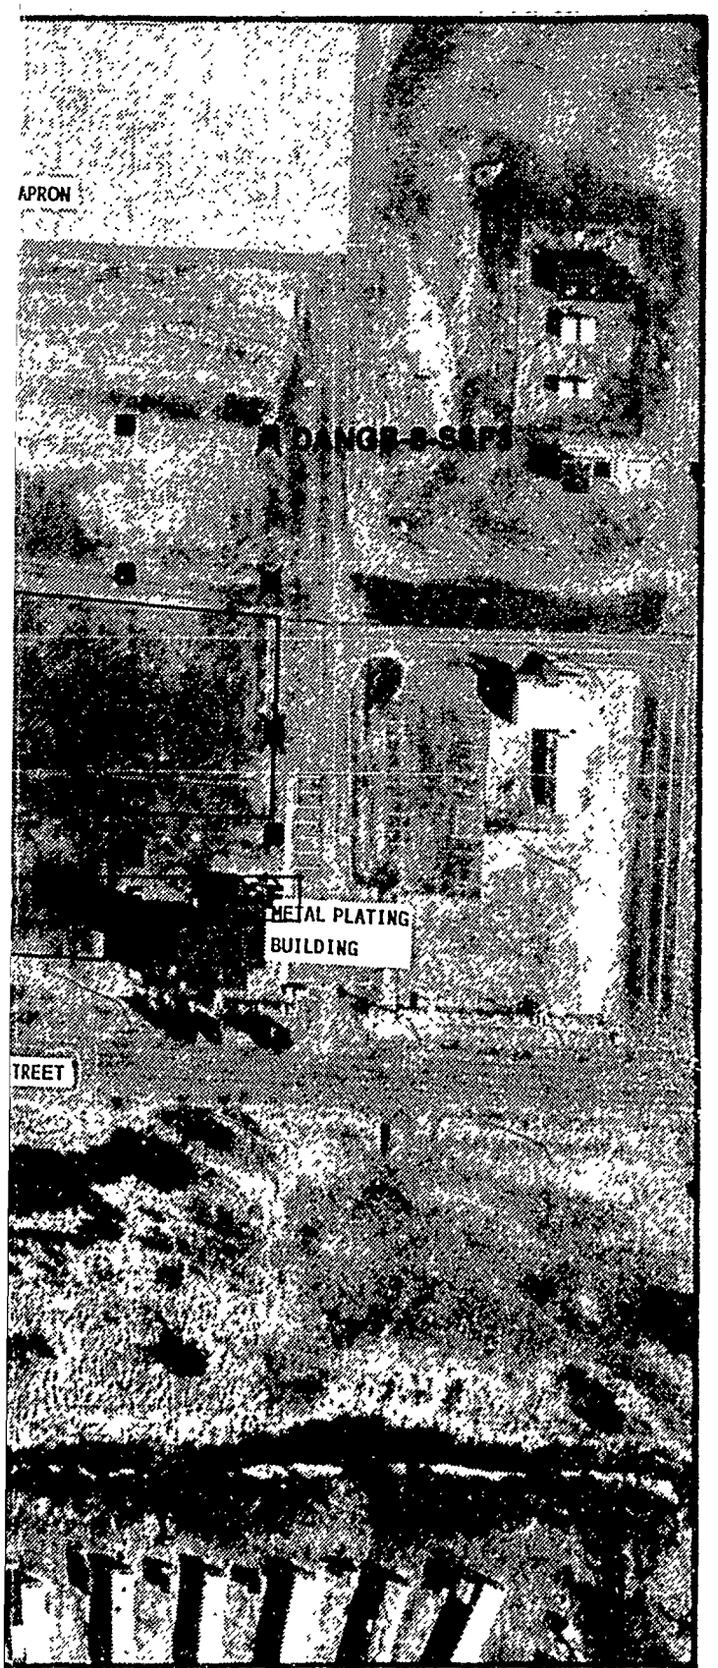
The results of a 24-point surface soil sampling survey indicated the presence of pesticides and PCBs in surface soils (Figure 4-10). The most commonly occurring pesticide, 4,4'-DDT, was present in concentrations ranging from 20 to 1,500 ug/kg (Table 4-32). PCB 1254 was detected at 330 ug/kg in sample DANGB-8-SSD1.
